THE SEARCH FOR MAWSON'S AIR TRACTOR

DR CHRIS HENDERSON
Mawson's Huts Foundation

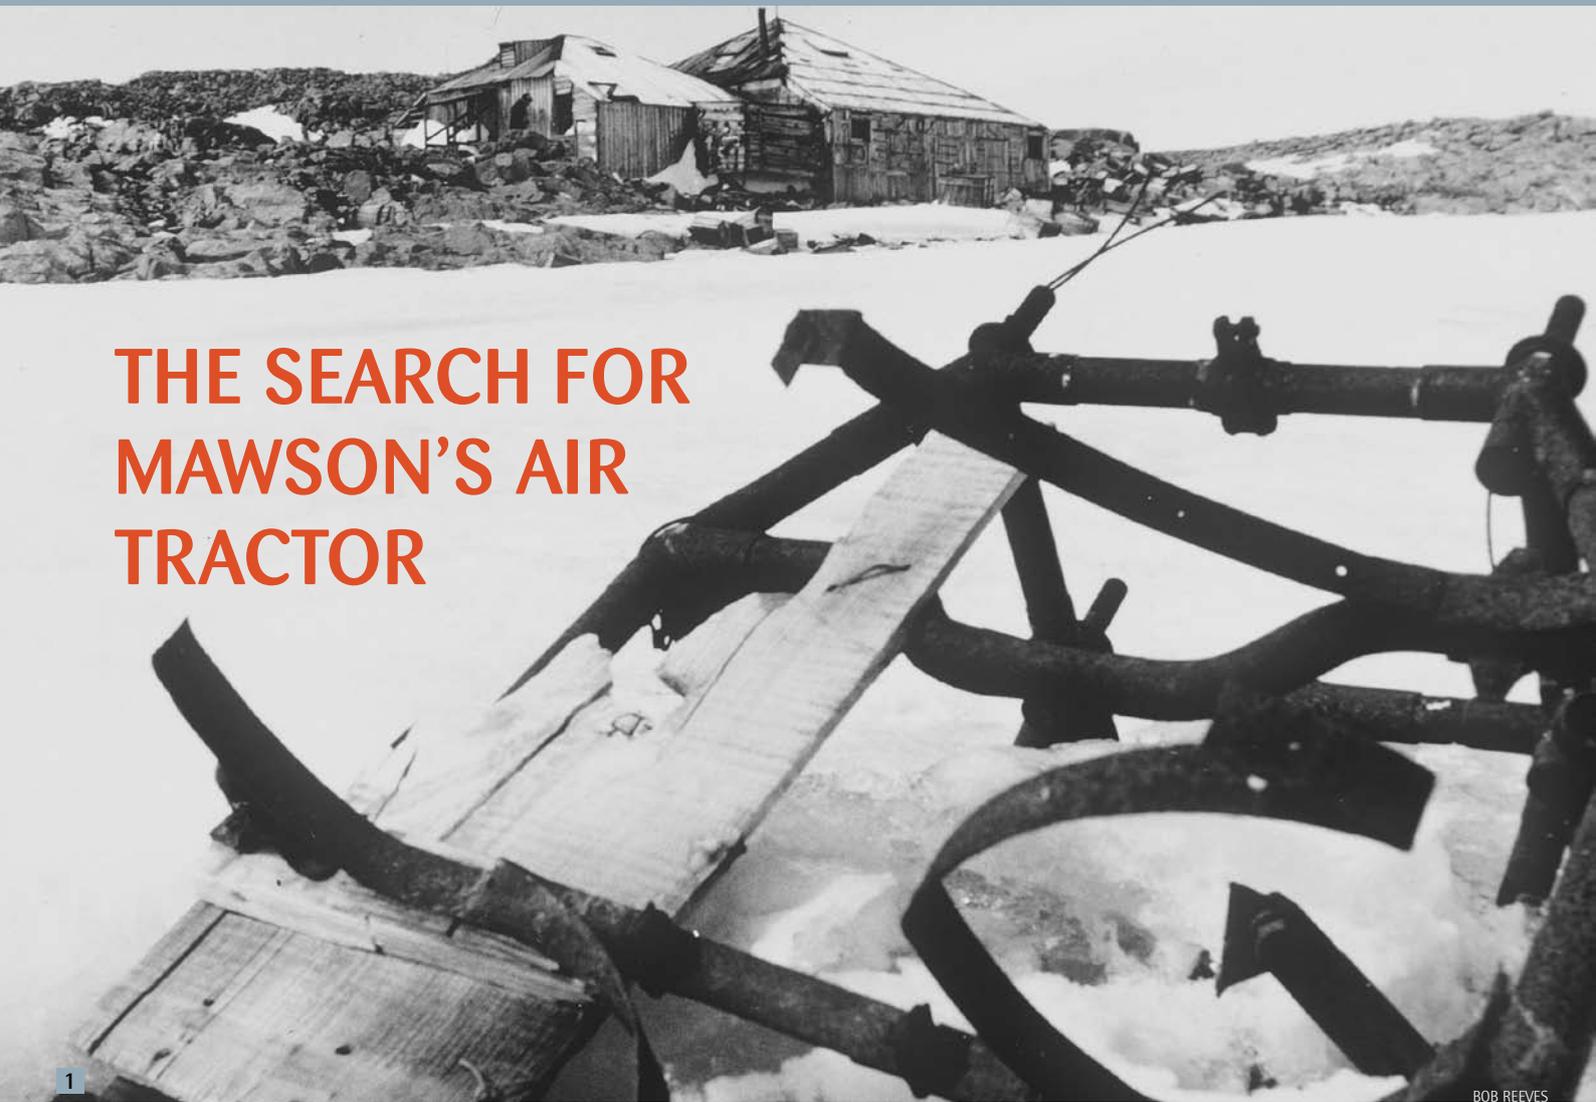
1

1. Last photo of the frame taken in 1976 by Australian Antarctic Division photographer Bob Reeves. The frame has not been seen since.
2. Bickerton with the air tractor. Note the third custom-built seat which was cut from the frame, and recently found at Cape Denison among the rocks across the harbour. The frame is at least 2.5 m tall.
3. The frame in 1931, as left on the ice in 1913. Note the mid-section containing the seat has been removed, and the last 3 sections of the frame have also gone.
4. Remains of an air tractor seat found and catalogued in 2008 by Anne McConnell. The seat was found on the northeastern edge of Boat Harbour about 200 m from the frame. Note the remnant of canvas on the back of the wooden platform.

The frame remained on the ice for 63 years, before it disappeared. Bob Reeves, an Antarctic Division photographer, took the last photograph in 1976, showing all but 500 mm of the frame buried in the ice. By the next expedition in 1981, there was no frame. It seemed to me that the frame could not possibly have blown away (as some suggested), and the ice had been shown not to move, so the frame must have sunk in the ice. But photographs showed little sinking for about 60 years, so why had it disappeared between 1976 and 1981? A study of the continuous temperature records from Dumont d'Urville station (200 km away) showed that there was an extended period of high temperature in the years 1976 and 1981. Comparison between Cape Denison and Dumont d'Urville data showed the temperature could be up to 10 degrees higher at Cape Denison.

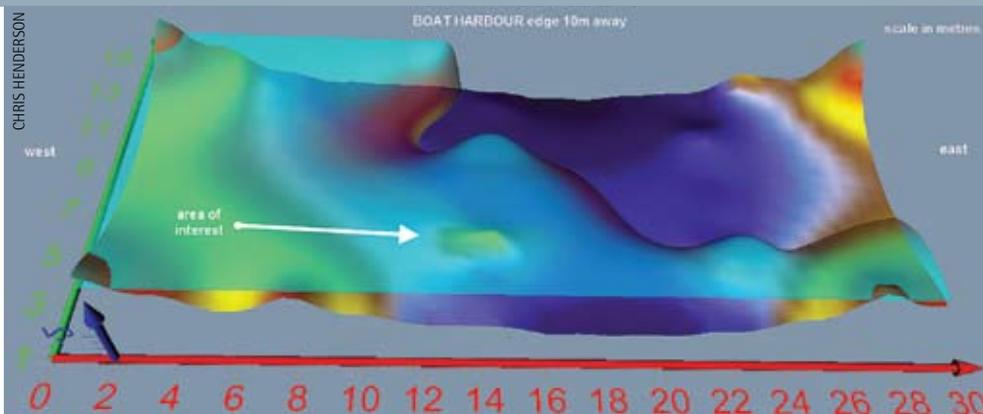
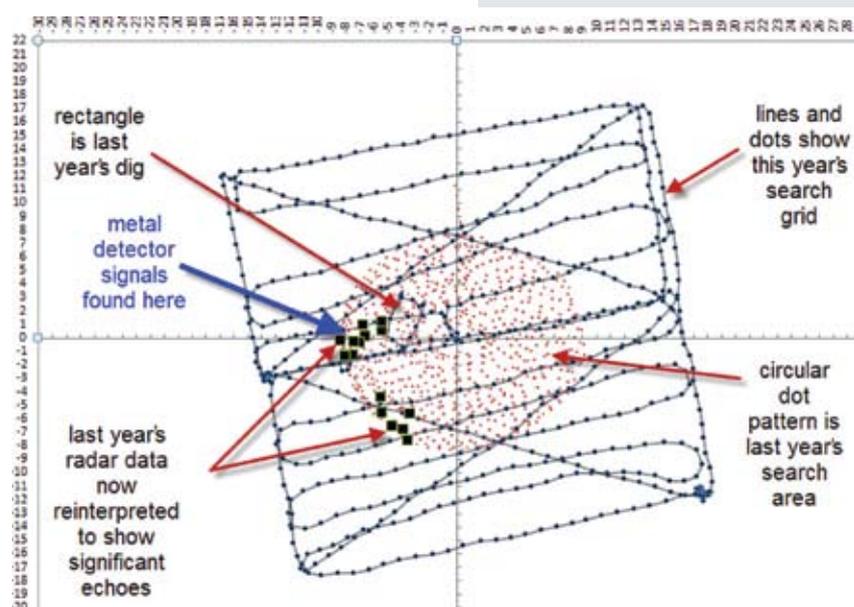
The top graphic shows the shape of underlying rock in false colours with blue being the deepest layer. Superimposed over this bedrock is a transparent layer where we found hard ice when drilling. The cutaway area of this transparent layer shows where soft ice forms a 'bay' in the search area. This soft ice completely melted away at some stage and seaweed was recovered from areas of soft ice during the search. The anomaly at 14, 6 is roughly where the air tractor should lie.

The second graphic shows the story so far. The grid pattern is the search area, mapped using differential GPS. The red dots show the 2008 ground penetrating radar data and the black squares show the significant radar anomalies – the metal detector showed something in one of these areas.
